# **Trailer Hitch Height vs. Mazda Dent**

Technical Analysis Report  
Prepared for: ICBC Claim CT94232-1

Robert K. Miller / RKMInsights  
July 1, 2025  
Victoria, BC

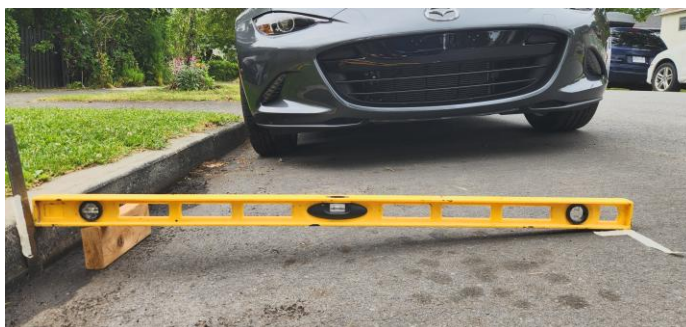
*There is a 3 ¾ inch rise from the curb edge road surface to the surface at curb plus 48 inches.*

This slope geometry means that a truck angled slightly toward the curb—rather than parked parallel—has its front end sitting lower than its rear, e.g. when one front tire nears or touches the curb. This downward tilt acts like a lever: as the truck's front-end dips down along the sloped road, the rear—and with it, the trailer hitch—pivots slightly upward around the rear axle.

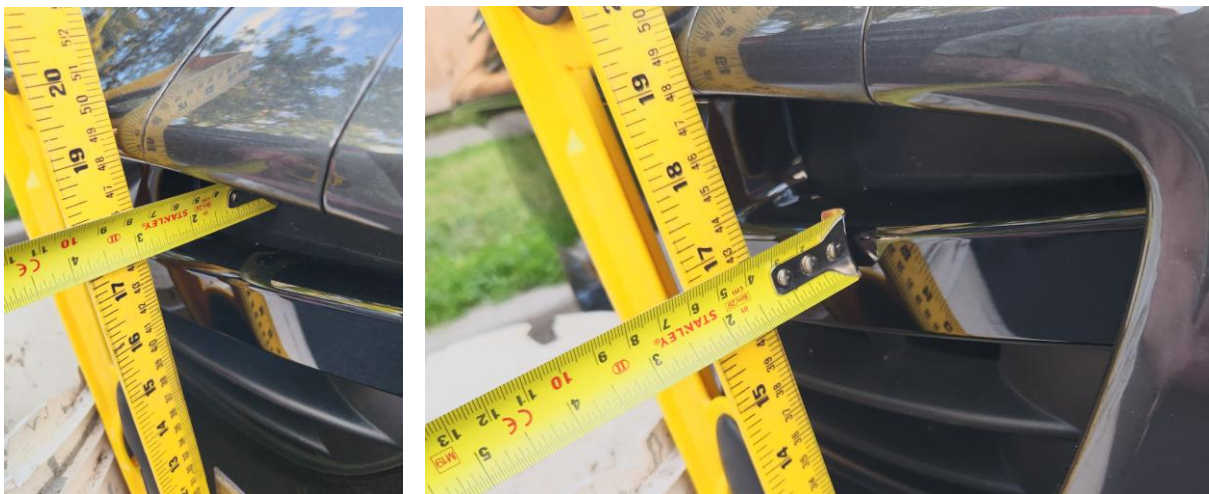
*Below the dent area on the leading edge, the bumper is recessed by ~ 2 7/8" & 1 3/8".*

In this configuration, the trailer hitch ball itself becomes the forward-most part of the hitch to make contact. The lower structure simply slides under the bumper's forward edge. This matches both the nature of the impact and the absence of damage to any lower bumper components.

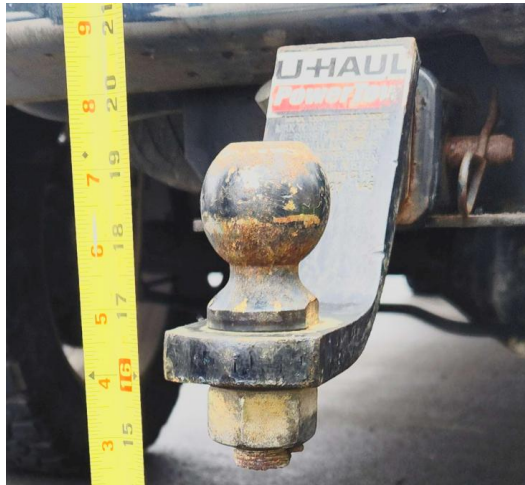
*Hitch platform below the ball extends only ~1/2 inch beyond vertical plane of the ball diameter.*  
Refer also to section **8. Photo Evidence and Illustrations**.

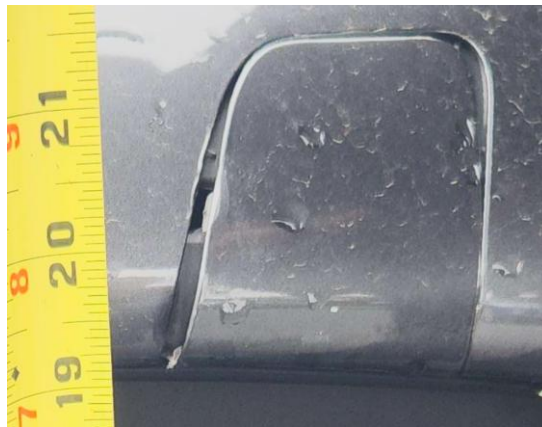
This impact point would naturally force the trapezoidal cover inward and slightly upward into the bumper's compartment space. This explains the slight bending seen along the compartment sides to the right and above the dent, as the wider lower part of the trapezoid was driven upward into the narrower portion of the opening.

*Photo showing minor dent at seam and slight deformities at edges of cover ~1" above the dent.*

The resulting deformation—minor bending at the rim and slight twisting of the dislodged cover—matches exactly what one would expect from this contact. The cover is designed to pop outward when pried from the outside, but here it was forced inward, deforming the

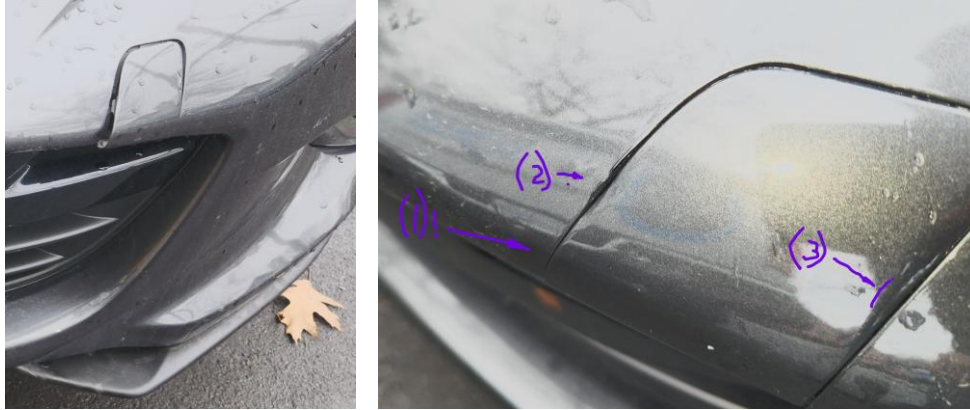
compartment rim just enough for the cover to twist free and spring out to its final dislodged position, as shown in the photos.

*First photo: dislodged cover as discovered. Second photo: purple arrows point to damage.*

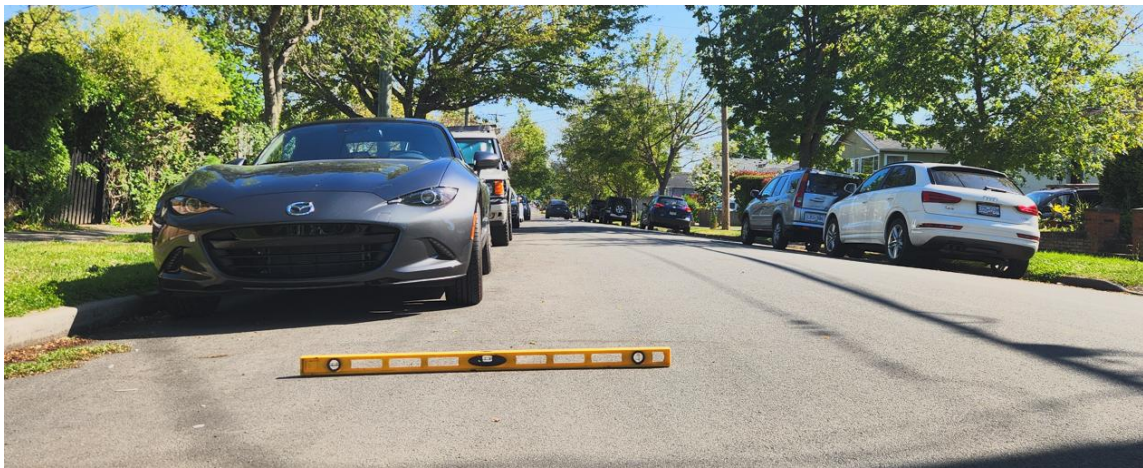
**8(a)1:** Wide-angle photo of Scott Street at incident site showing the parabolic road crown. Used to illustrate how road geometry contributes to vehicle tilt.

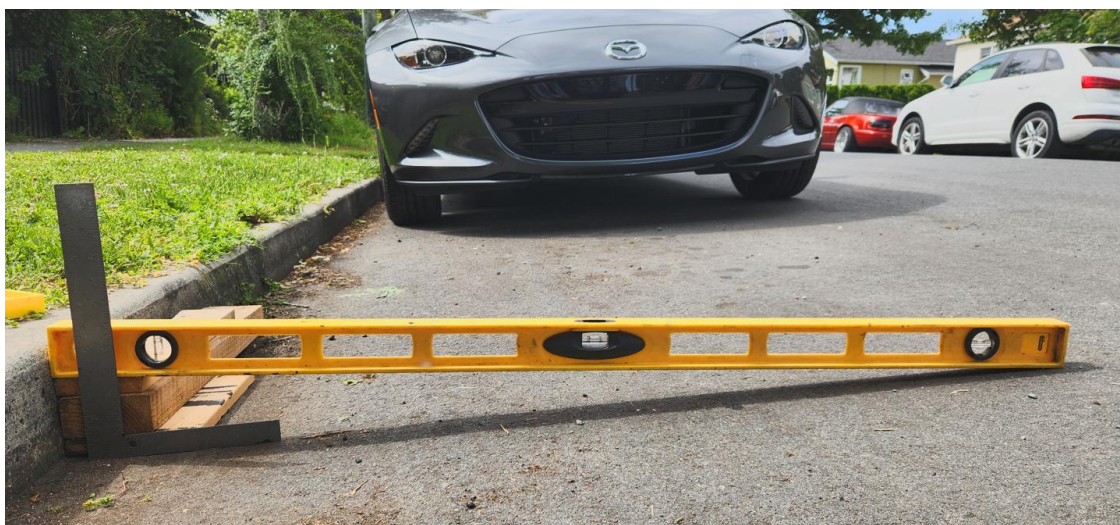
**8(a)2:** Front-on view of the Mazda MX-5 with a level placed across the street to help visualize road slope.

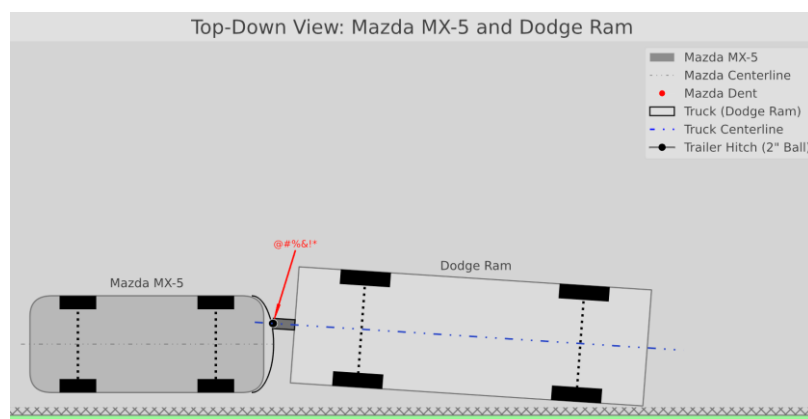
**8(b)3:** Overhead illustration with hitch aligned with dent, and the Dodge Ram angled slightly to show its probable position upon contact with Miata.

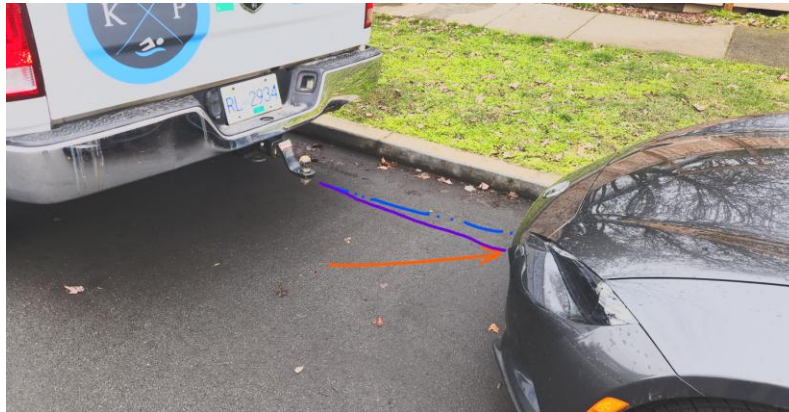
**8(b)4:** Annotated photograph of the parked vehicles. The sketch tracing shows truck centreline (blue dashes), the inferred truck path (purple) to its final parking position after contact with the dent location (red) on the Mazda bumper.

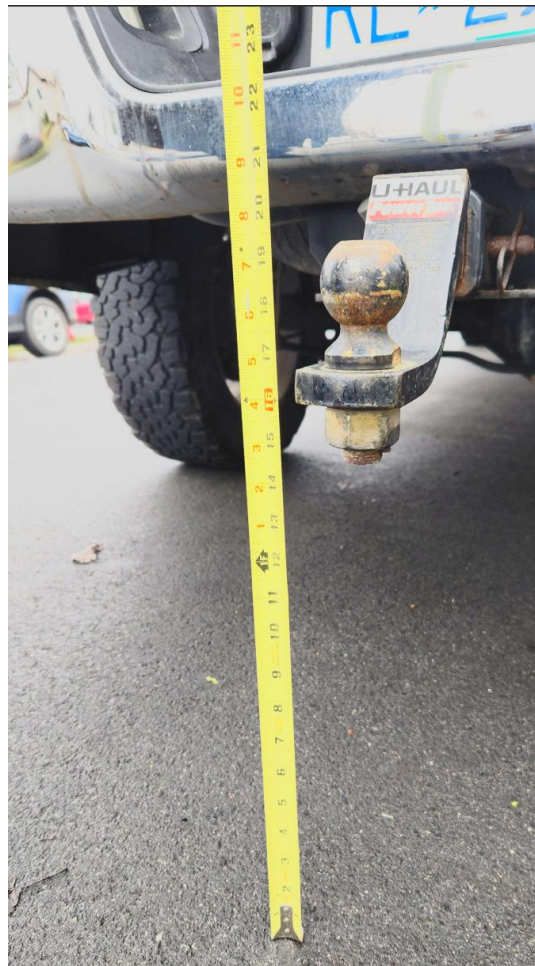
**8(c)1:** Dodge Ram trailer ball at ~18.5" above ground (while parked approx. parallel to curb)

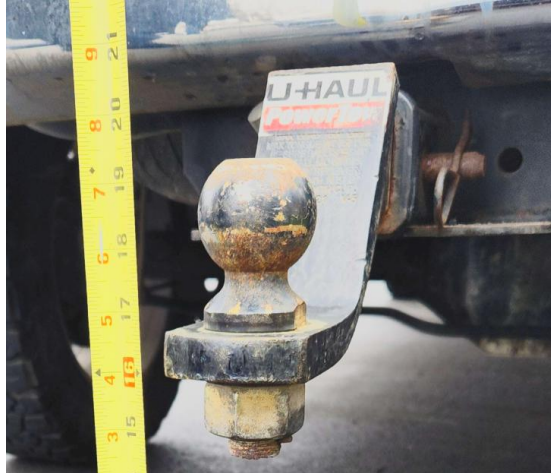
**8(c)2:** Trailer ball and hitch platform on Dodge Ram, showing 2" trailer ball and the approximately 3/8 to 1/2 inch rearward protrusion of the hitch platform below.

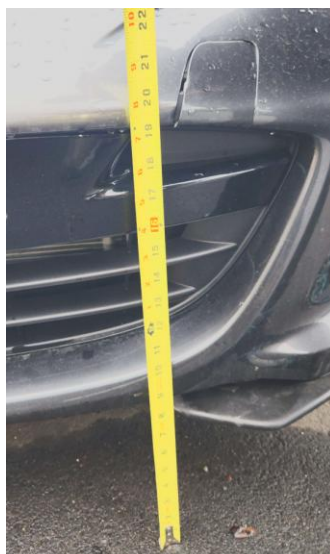
**8(d)1:** Mazda dent at ~19.4" from the ground, measured at the scene.

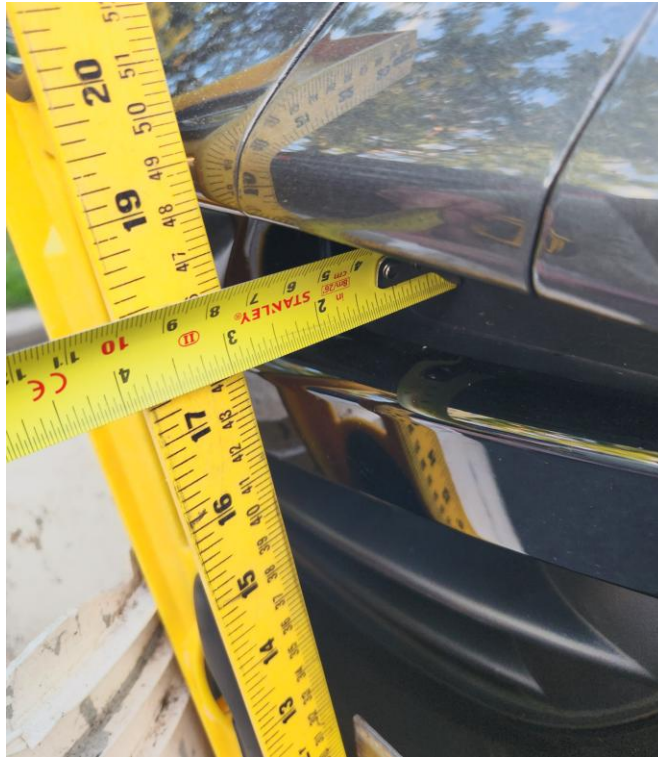
**8(d)2:** Mazda bumper recesses inwards  $\sim 2 \frac{7}{8}$ " immediately below the dent area (photo taken after repairs.)

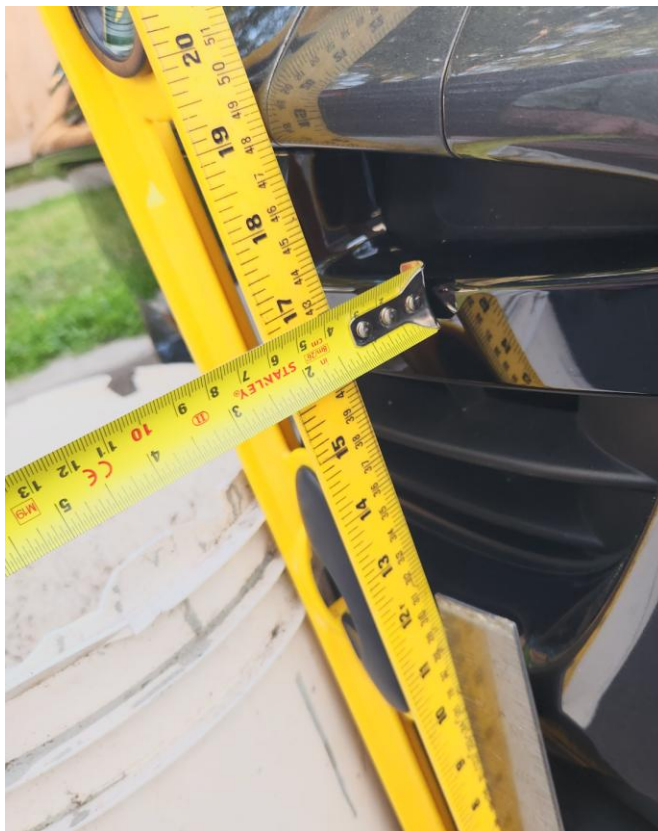
**8(d)3:** Mazda bumper is recessed inwards  $\sim 1 \frac{3}{8}$ " at  $\sim 2 \frac{1}{4}$ " below the dent area (photo taken after repairs.)

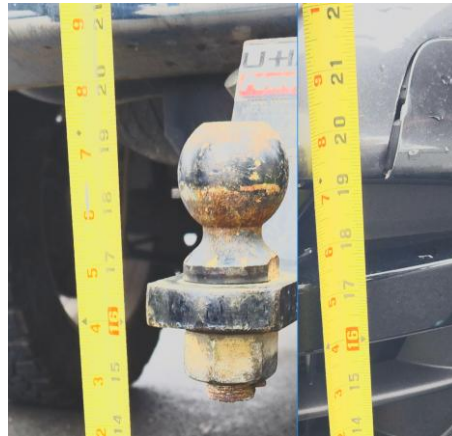
**8(d)4:** Side-by-side composite: hitch ball and bumper dent, aligned to show vertical height measurements (i.e. vehicles are **not** angled across a sloped roadway as at moment of impact.).
